ANALYSIS SUMMARY CALCULATION

The following summary calculation was generated from the results of a CRANE GIRDER PRO structural analysis. The crane girder failed due to the type of cracks shown in Photograph #4 of the section on Crane Girder Failure. The analysis resulted in the replacement of over 10 crane runway girders in length of 50 ft. and 75 ft.

CONSULTING ENGINEER
 STRUCTURAL
 CIVIL

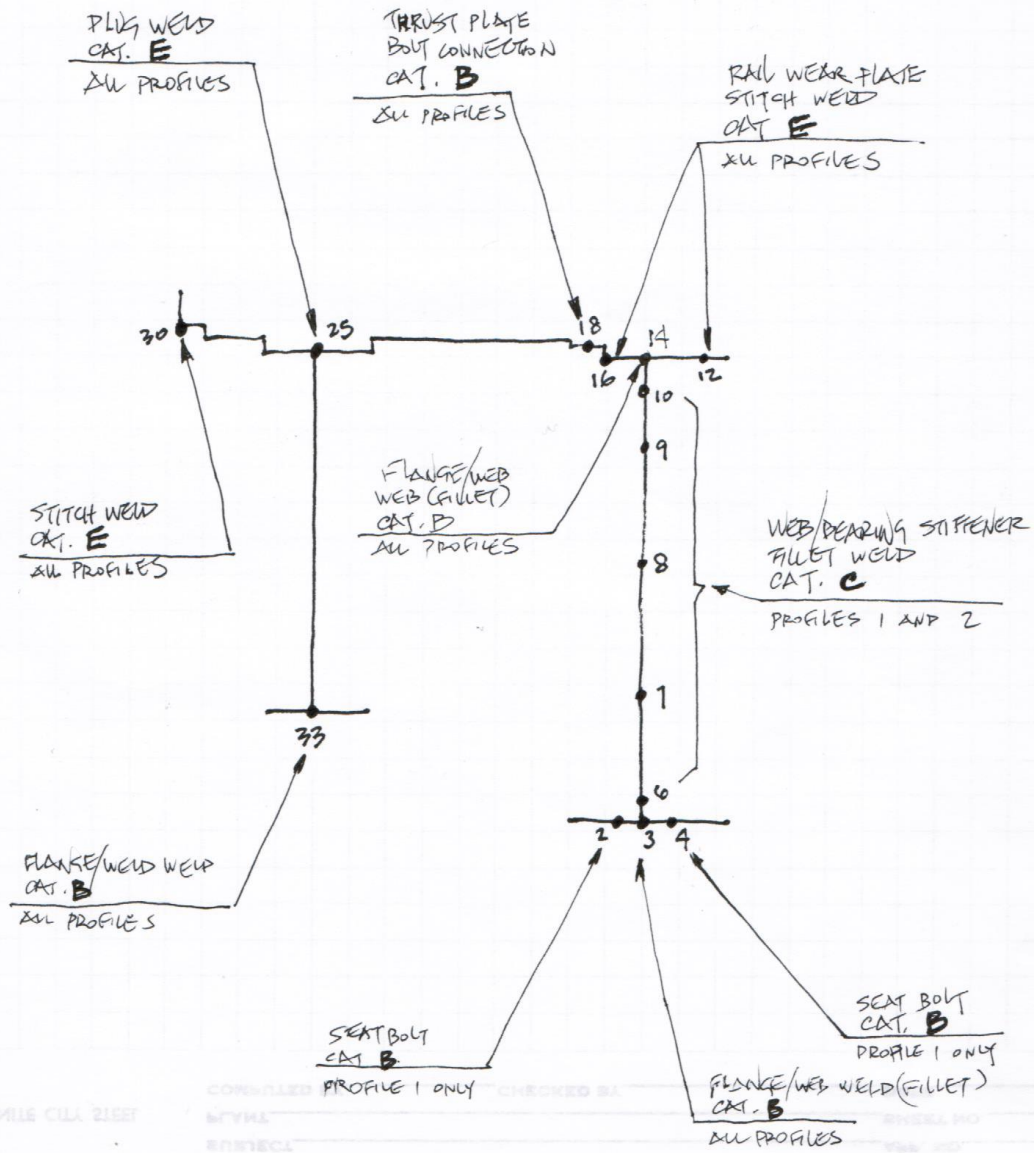
GIRDER ZONE DEFINITION

TYPICAL PROFILE SETUP

PROFILE TYPE	$\left. \begin{matrix} 1 \\ 2 \\ 3 \end{matrix} \right\}$	APPLIES TO	$\left\{ \begin{matrix} GIRDER END W/ BEARING STIFFENERS \\ \text{INTERMEDIATE SECTION W/ WEB STIFFENERS} \\ \text{INTERMEDIATE SECTION STIFFENER FRGE} \end{matrix} \right.$
--------------	---	------------	---

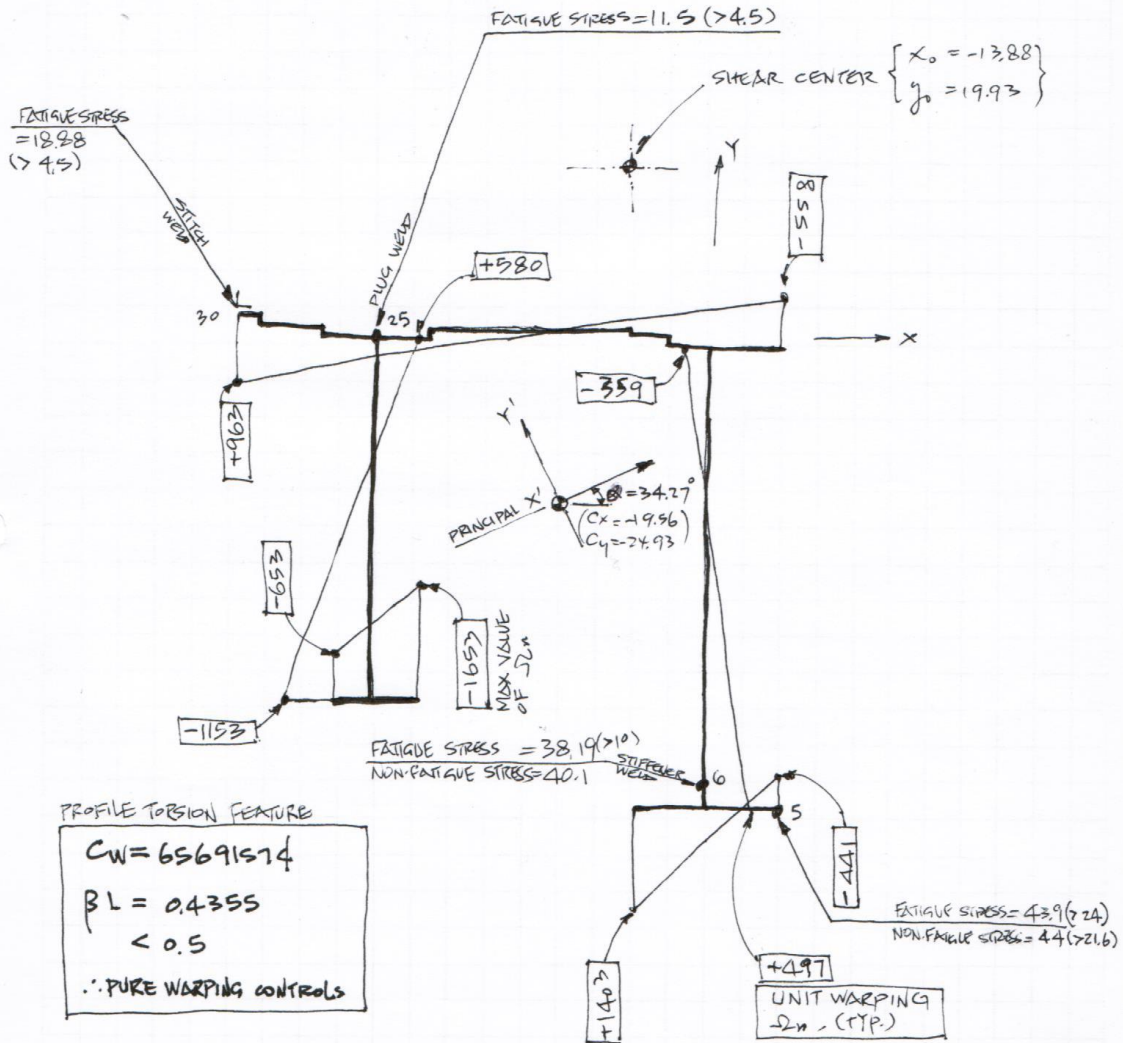
ZONE II RESULT OVERVIEW

EXISTING GIRDER EVALUATION COMMENTS GSEXFLD 4

1. GIRDER PROFILE RESEMBLES AN UPSIDE-DOWN U OR A LAY-DOWN CHANNEL SECTION, FOR WHICH THE SHEAR CENTER IS WAY ABOVE THE CHANNEL WEB. THEREFORE THE ENTIRE GIRDER SECTION IS PREDISPOSED TO ROTATE ABOUT THE SHEAR CENTER WHEN LOADED AT TOP OF THE RAIL FROM THAT THE RESULTANT "RARELY" PASSES THROUGH THE SHEAR CENTER.

2. TORSION CHARACTERISTIC CONSTANT $\beta = 0.0007258$, LENGTH $L = 600$. $\beta L = 0.4355$. ANY SUCH βL MAGNITUDE, LESS THAN 0.5, WOULD CLEARLY INDICATE THAT ST. VENANT TORSION (COMPARING WITH WARPING) IS RELATIVELY MUCH TOO SMALL TO HAVE PRONOUNCED EFFECT. THEREFORE THE GIRDER'S TORSIONAL BEHAVIOR WOULD BE CONTROLLED BY "PURE WARPING".

3. FIBER STRESS AT NODES IN THE BOTTOM FLANGE AND THE LOCALITY IS GENERALLY HIGHER THAN THAT ELSEWHERE. THIS IS TRUE FOR ALL ZONES DUE TO THE FACT THAT THE DISTANCE TO THE CENTROID AND/OR SHEAR CENTER FROM THESE NODES ARE INHERENTLY FARTHER THAN THAT FROM OTHER NODES.

4. EXCEPT FOR THE END ZONES (1, 2, 20, 21) UP TO ABOUT 5 FT FROM THE SUPPORTS, THE GIRDER IS FOUND OVERSTRESSED UNDER NON-FATIGUE LOAD AT VARIOUS HOT SPOTS IN ALL OTHER ZONES. TYPICALLY, HOT SPOT INCREASES IN NUMBER FROM MINIMA IN ZONE 3/19 TO THE MAXIMA TOWARDS CENTER ZONE 11.

5. SUBJECTED TO REPEATED STRESS FLUCTUATIONS, THE BASE METAL SHOULD DEVELOP CRACKS AT MOST HOT SPOTS ESPECIALLY IN ZONE 11. LISTED AS FOLLOWS ARE SOME OF THE HIGHEST RATIO OF BASE METAL FATIGUE STRESS (REVERSAL) TO DISC ALLOWABLE FSR VALUES UNDER FATIGUE LOAD CONDITION 4 ARE:

4.2 (= 18.8 / 4.5)	}	AT NODE 30 - KICK ANGLE / # STITCH WELD
3.82 (= 38.19 / 10)		6 - WEB STIFFENER BASE WELD
2.56 (= 11.5 / 4.5)		25 - SUPPORT BEAM / # PLUG WELD
1.83 (= 43.9 / 24)		AT NODE 5 - BOTTOM FLANGE TIP (NO WELD)
