ANALYSIS SUMMARY CALCULATION

The following summary calculation was generated from the results of a CRANE GIRDER PRO structural analysis. The crane girder failed due to the type of cracks shown in Photograph #4 of the section on Crane Girder Failure. The analysis resulted in the replacement of over 10 crane runway girders in length of 50 ft. and 75 ft.

CONSULTING ENGINEER
 STRUCTURAL
 CIVIL

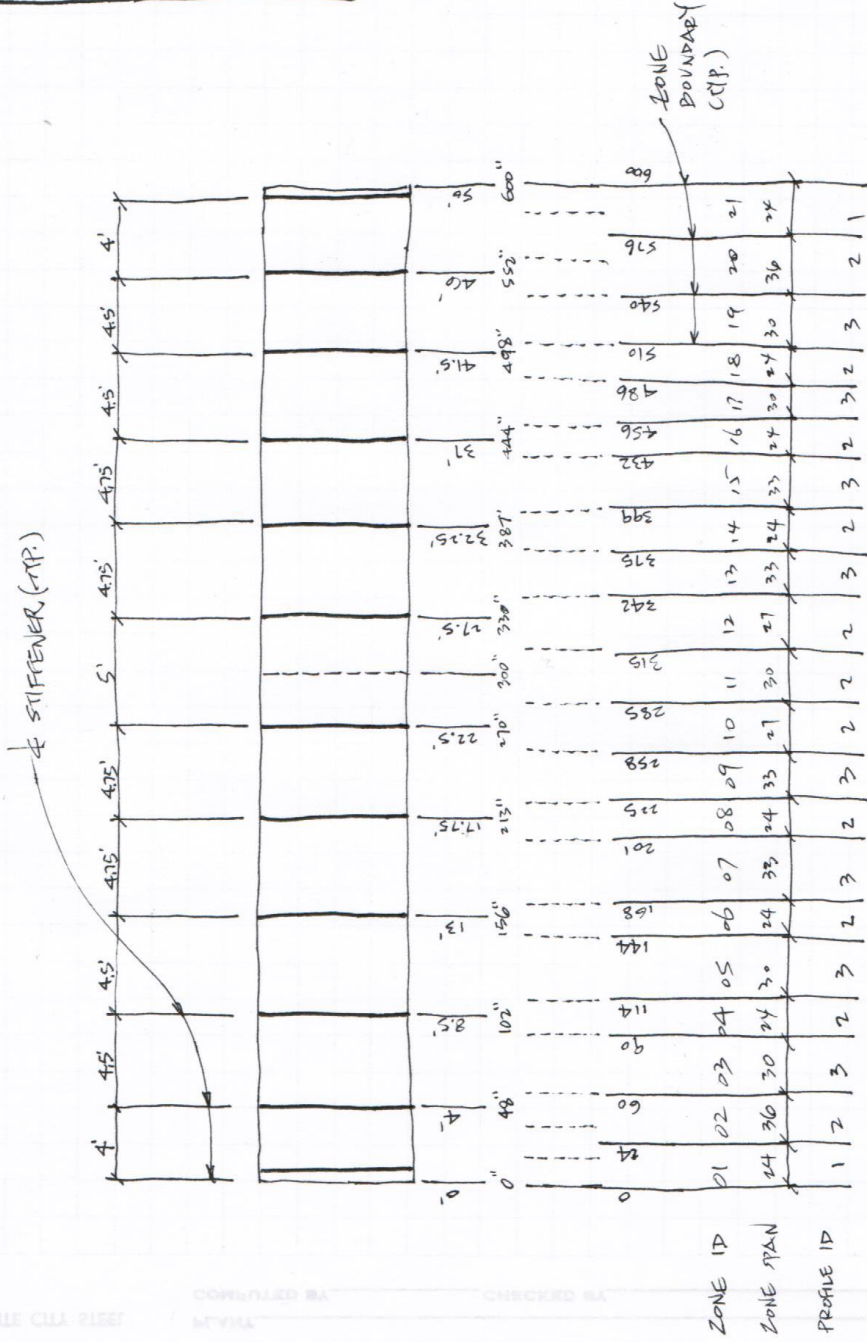
ZONE II RESULT OVERVIEW

4. EXCEPT FOR THE END ZONES (1, 2, 20, 21) UP TO ABOUT 5 FT FROM THE SUPPORTS, THE GIRDER IS FOUND OVERSTRESSED UNDER NON-FATIGUE LOAD AT VARIOUS HOT SPOTS IN ALL OTHER ZONES. TYPICALLY, HOT SPOT INCREASES IN NUMBER FROM MINIMA IN ZONE 3/19 TO THE MAXIMA TOWARDS CENTER ZONE 11.

5. SUBJECTED TO REPEATED STRESS FLUCTUATIONS, THE BASE METAL SHOULD DEVELOP CRACKS AT MOST HOT SPOTS ESPECIALLY IN ZONE 11. LISTED AS FOLLOWS ARE SOME OF THE HIGHEST RATIO OF BASE METAL FATIGUE STRESS (REVERSAL) TO DISC ALLOWABLE FSR VALUES UNDER FATIGUE LOAD CONDITION 4 ARE:
